COLORADO CULTURAL RESOURCE SURVEY

Architectural Inventory Form

| 5. | Historic building name: | J. B. Roby's Store, George B. Watson's Clothing & Gent's Furnishings Store | |
| 7. | Building address: | 101 S. Main Street | |

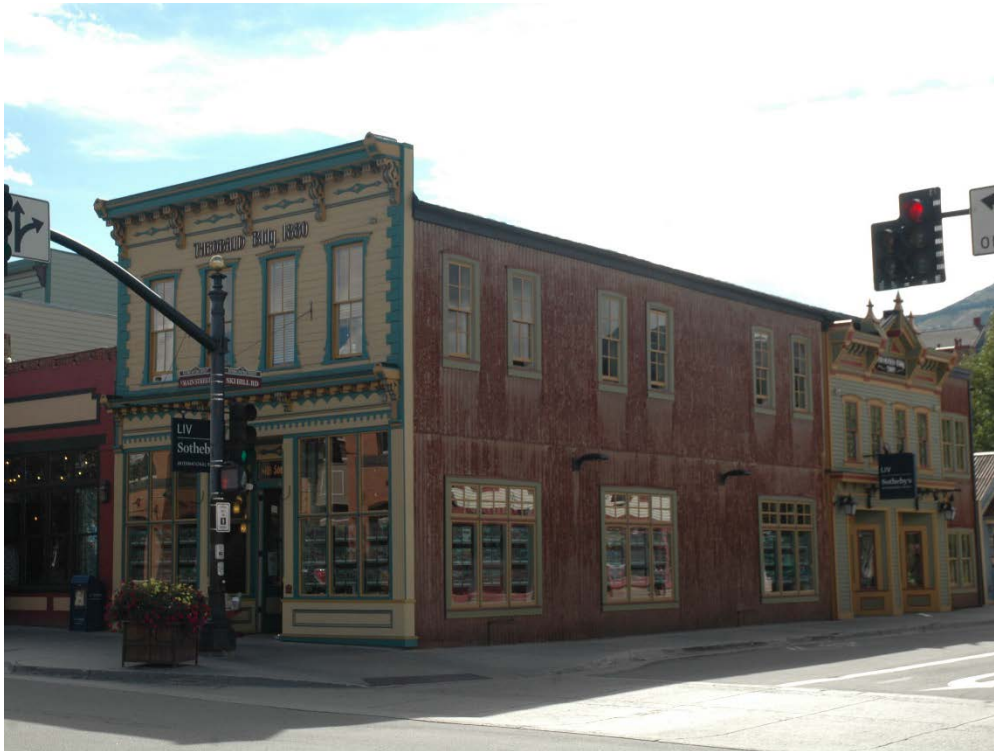
21. General architectural description:
This late 19th century commercial building occupies a choice retail lot at the southwest corner of Main Street and Ski Hill Road / Lincoln Avenue, in the heart of downtown Breckenridge. It is covered by a low-pitched front gable roof, hidden behind a tall parapet on the east-facing side (façade), and a lower parapet on the north-facing side. The façade fronts directly onto the wide public sidewalk that parallels Main Street. The original two-story portion of the building measures 25' N-S (across) by 59' E-W (deep). Facing onto Main Street, the façade is richly decorated with Italianate details executed entirely in wood. The lower façade is symmetrically arranged, containing a single storefront. The storefront features a centered recessed entryway flanked on either side by large expanses of fixed-pane storefront display windows. Within the centered entryway, there are two, painted blue and yellow, wood-paneled entry doors, each with two large upper sash lights. The storefront display windows have painted blue wood frames, and below these windows there are wood-paneled kick plates. Vertical wood columns, at either end of the façade, are grooved to simulate cast iron or stone pilasters. A projecting wood cornice separates the façade's first and second stories. The cornice is adorned by a dentil course, and beneath the cornice there are a series of decorative brackets and scrollwork with a series of trefoil motifs. The façade's second story wall contains four 2/2 double-hung sash windows, with painted yellow wood frames, painted blue wood surrounds, and simple wood pediments. The upper façade wall is composed

of painted cream yellow horizontal wood planks. Staggered, painted blue 1x boards at the corners of the façade's second story wall are designed to simulate stone or cast iron quoins. The topmost section of the façade wall forms a parapet that extends above the roof line. The top of the parapet is adorned by another projecting wood cornice with decorative scrolled brackets. A non-historic sign centered above the second story windows reads: "THEOBALD Bldg. 1880."

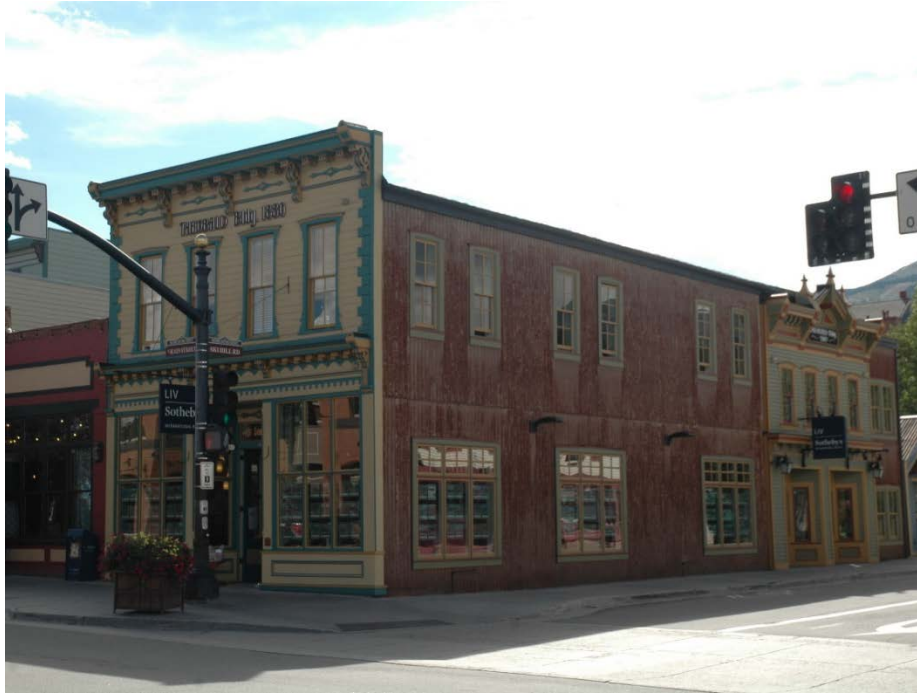
The eastern end of the north-facing wall (facing onto Ski Hill Road) is clad with corrugated sheet metal. The first story wall of this section contains three sets of tripled, large, single-light fixed-pane windows, with each window topped by four, small, single-light fixed-pane windows. These windows have painted yellow wood frames and painted green wood surrounds. The second story wall of this section contains six 4/4 double-hung sash windows with painted yellow wood frames, painted green wood frames, and simple wood pediments.

CD 1, Image 21, View to Southwest, of the east-facing (façade) wall and the north-facing wall

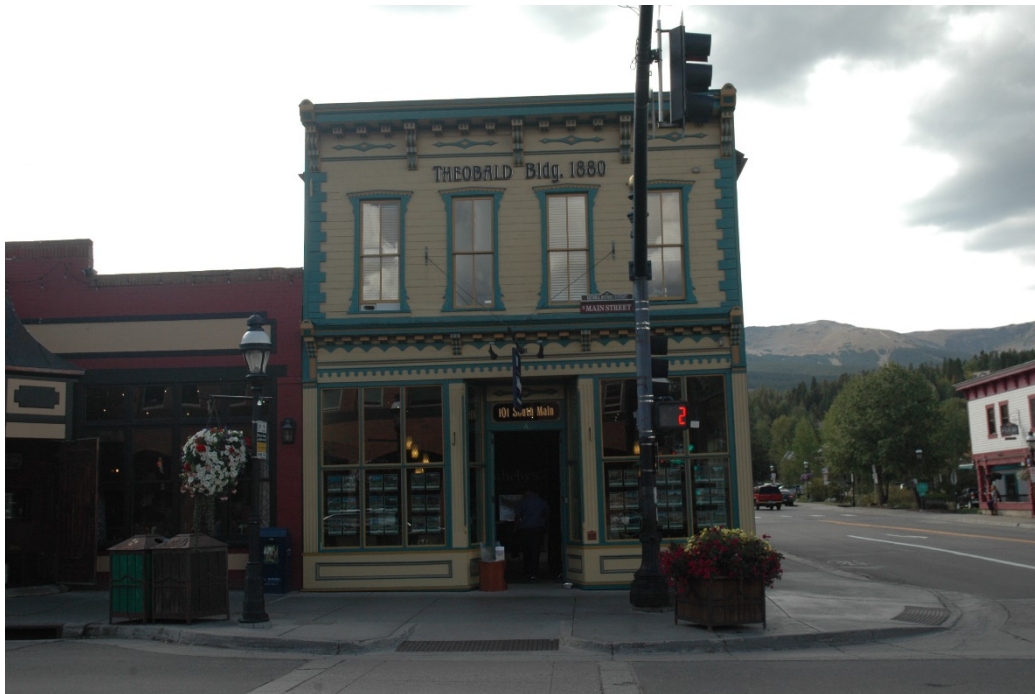
CD 1, Image 22, View to West, of the east-facing (façade) wall

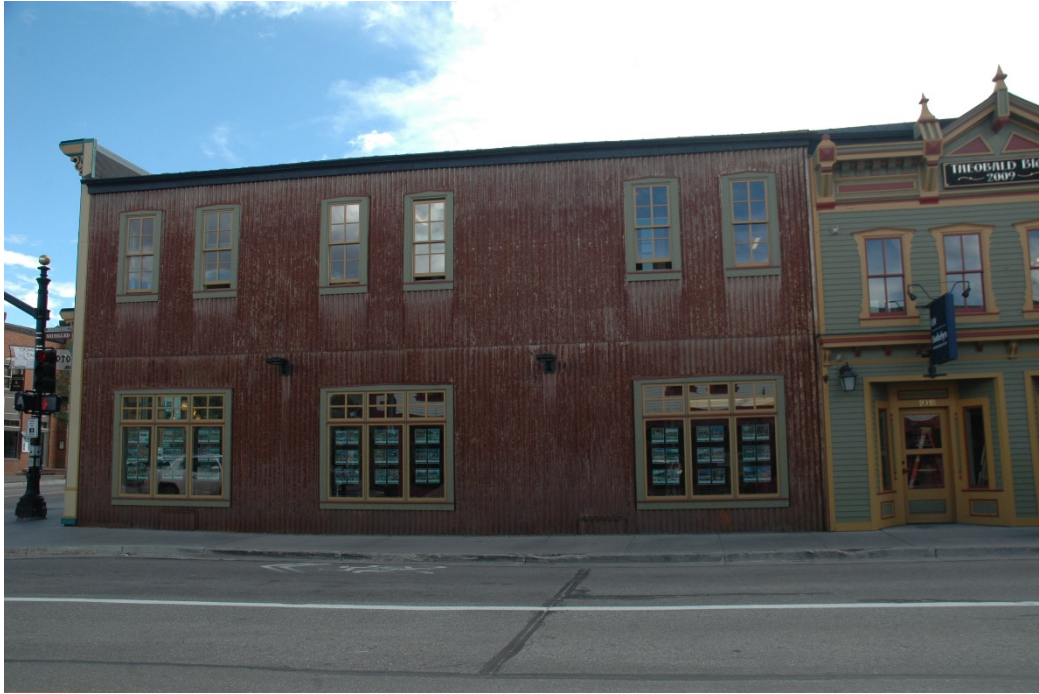
West of the section described in the preceding paragraph, a 20' section of the north-facing wall is clad with painted green horizontal wood siding with yellow trim with red accents. Dating from 2009, this portion of the building contains a double storefront in the main level, with a second story above. The north-facing wall here is topped by a symmetrical gabled parapet with an elaborate bracketed cornice. The double storefront contains two recessed entryways, each with a painted yellow wood-paneled door with two upper sash lights, and with flanking side lights. The second story wall of this section contains four 2/2 double-hung sash windows, with painted red wood frames, painted yellow wood surrounds, and simple wood pediments. The elaborate bracketed cornice is painted green, trimmed in yellow and red. Four muffin-shaped finials with pointed tops are at the apex of the raised gabled center portion of the cornice. Below this gabled section a non-historic sign band with silver lettering on a painted black background is inscribed "THEOBALD Bldg. 2009."

CD 1, Image 23, View to South, of the north-facing wall

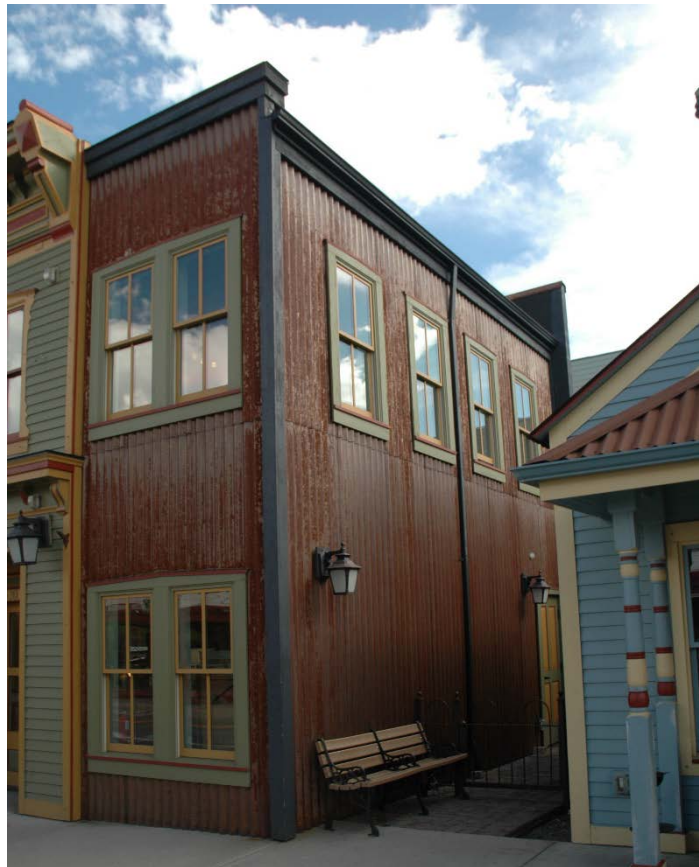
The western-most end of the building is also composed of a 2009 two-story addition (that replaced a historic one-story gabled addition). The exterior walls of this addition are clad with corrugated sheet metal. The north-facing wall contains a set of paired 2/2 double-hung sash first-story windows, and a set of paired 2/2 double-hung sash second story windows. The west-facing wall of this section contains four 2/2 double-hung sash second story windows. The window in this section all have painted yellow wood frames and painted green wood surrounds. A painted yellow and green wood-paneled door enters near the south end of the west-facing wall.

CD 1, Image 24, View to Southeast, of the west-facing wall, and the west end of the north-facing wall

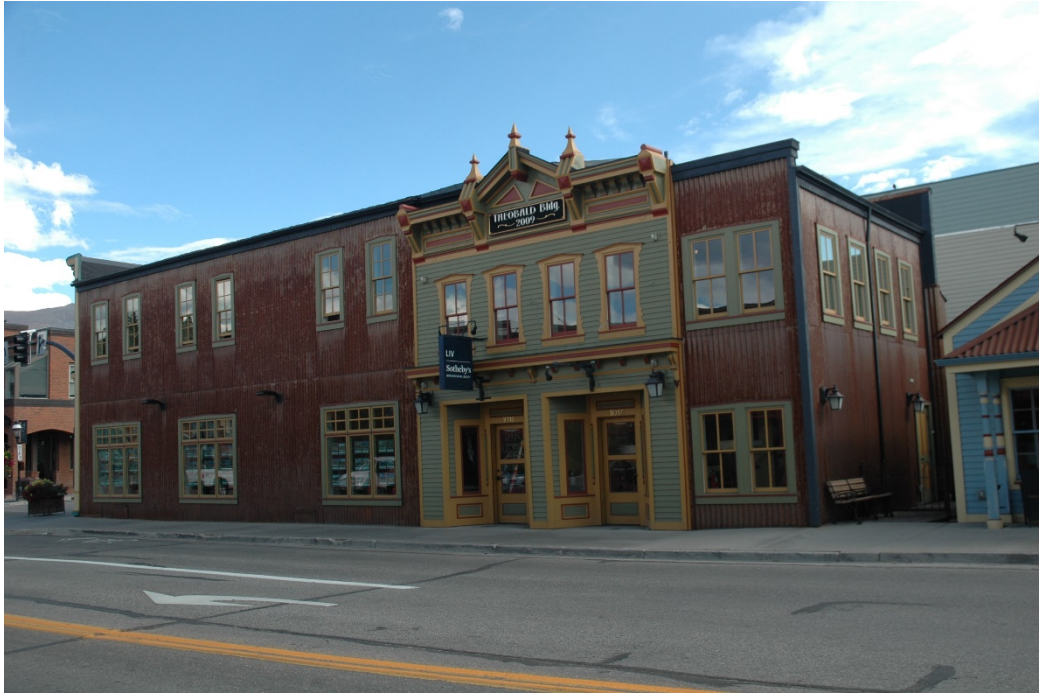
CD 1, Image 25, View to Southeast, of the north-facing wall and the west-facing wall

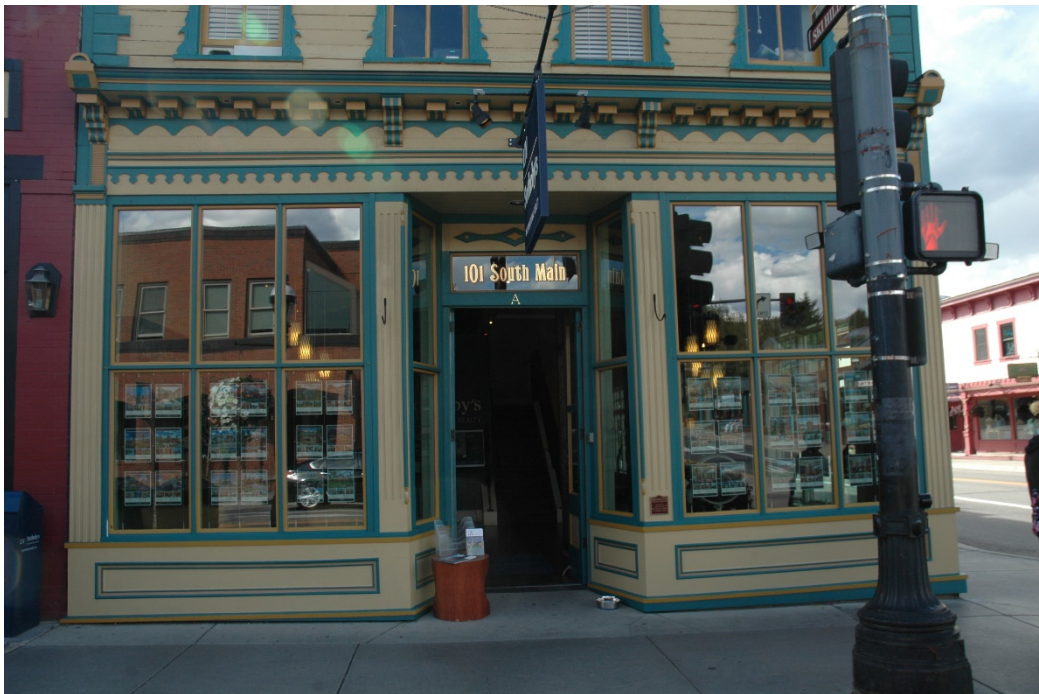
CD 1, Image 26, View to West, of the lower facade
