COLORADO CULTURAL RESOURCE SURVEY

Architectural Inventory Form

| 5. Historic building name: | Purbaugh Barn | |

48. Report title: **Town of Breckenridge Phase V Cultural Resource Survey**49. Date(s): **June 30, 2010**50. Recorder(s): **Carl McWilliams, Rebecca Waugh, Timothy Wilder**51. Organization: **Cultural Resource Historians**52. Address: **1607 Dogwood Court, Fort Collins, CO 80525**53. Phone number(s): **(970) 493-5270**

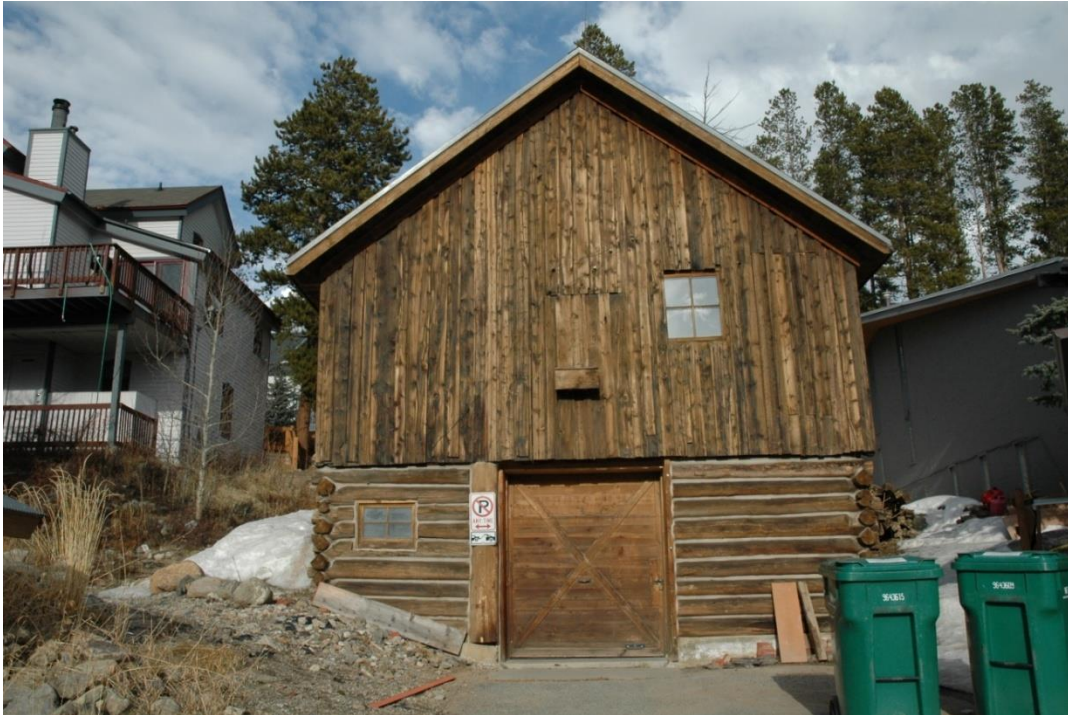
18. Roof configuration: **Gabled Roof/Front Gabled Roof**
19. Primary external roof material: **Metal Roof**
20. Special features: **N/A**
21. General architectural description:
The Purbaugh/Batcheller Barn is a two-story, rectangular-shaped, building of log and wood frame construction. Built into a hill slope which rises from west to east, the barn is supported by a non-historic concrete foundation. The first story walls are made of whole logs which range from approximately 7½ feet above grade on the west elevation (façade) to just one foot above grade on the east (rear) elevation. The front corners overlap slightly and are V-notched or saddle-notched. The barn's second story walls are entirely above grade, and are clad with unpainted vertical wood planks. The barn roof is a moderately-pitched front gable, with corrugated metal roofing material and with unpainted boxed eaves. A metal stovepipe protrudes through the roof near the east end of the north-facing roof slope. A horizontal weatherboard door, with X-bracing, which slides horizontally, is centered on the first story's west elevation. A vertical wood plank door, side-hinged with metal strap hinges, enters the second story near the south end of the east elevation. A low vertical wood plank covered opening, side-hinged with metal strap hinges, enters the second story, just above the foundation on the east elevation. Small single 4-light windows penetrate the second story on the south and west elevations. Another single 4-light window penetrates the north end of the west elevation on the first story. Another small 4-light window is located in the east elevation's upper gable end.
