COLORADO CULTURAL RESOURCE SURVEY

Architectural Inventory Form

1. Resource number: **5ST.130.133** Parcel number(s):
2. Temporary resource no.: **N/A** **2211313419005**
3. County: **Summit**
4. City: **Breckenridge**
5. Historic building name: **Spencer House**
6. Current building name: **Harris House**
7. Building address: **206 S. French Street**
8. Owner name and address: **Anthony Harris, Ann Harris**
P. O. Box 1203
Breckenridge, CO 80424

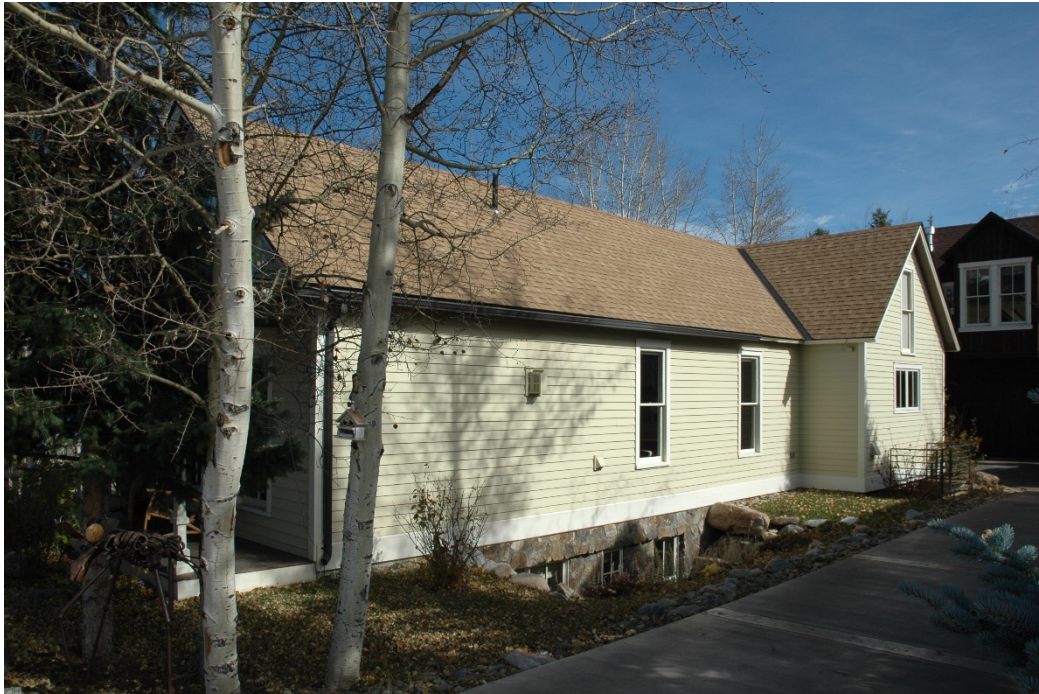
CD 1, Image 8, View to Northeast, of the south-facing wall of the original dwelling.

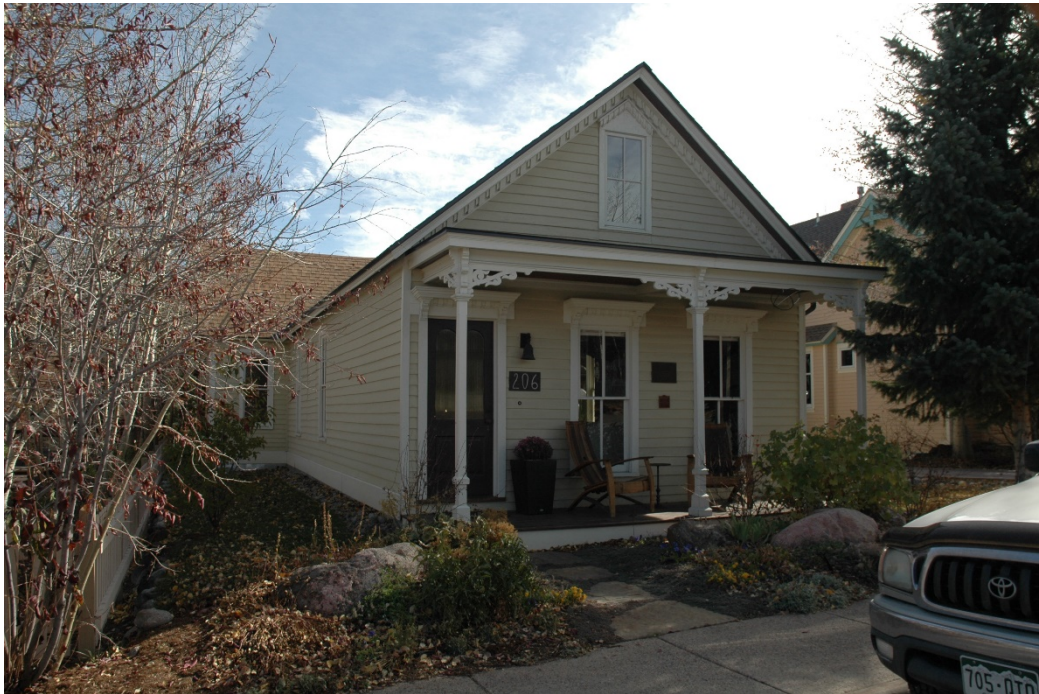
Painted white wood frames and surrounds. A painted purple wood-paneled front door, with an upper sash light, is near the north end of the façade. This door enters the dwelling from an open front porch that extends across the entire façade. The porch features a wood floor, a bead board ceiling, chamfered wood posts with decorative brackets, and a low-pitched hipped roof. A non-historic (2014) dormer is in the east-facing roof.

CD 1, Image 9, View to Southeast, of the west-facing (façade) wall and north-facing wall of the original dwelling.

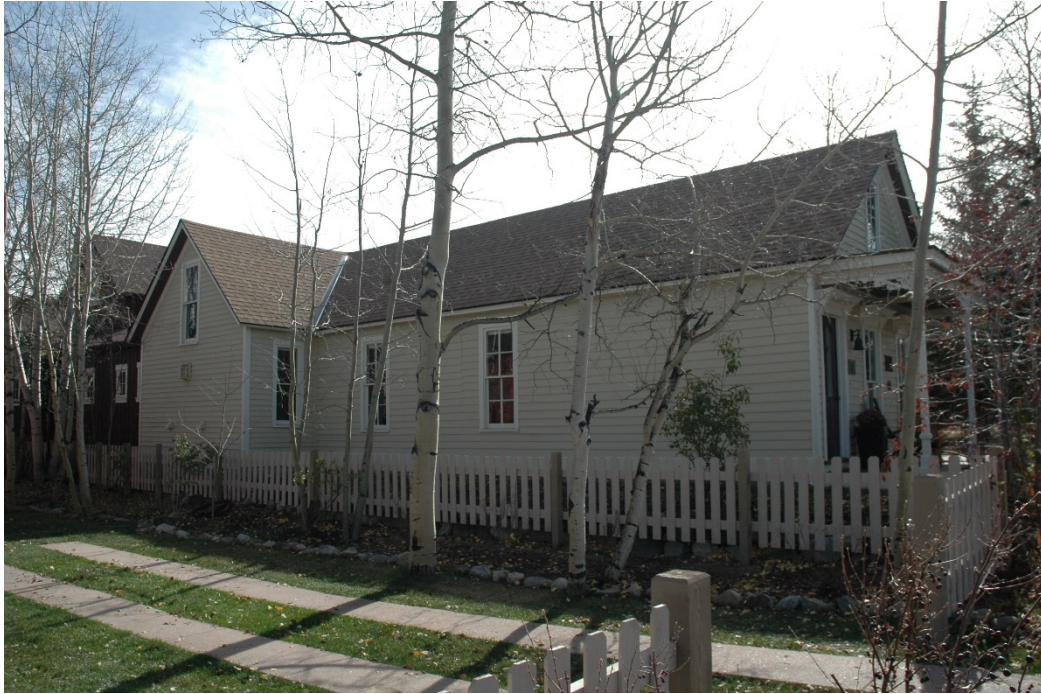
CD 1, Image 10, View to Southeast, primarily of the north-facing wall of the original dwelling.

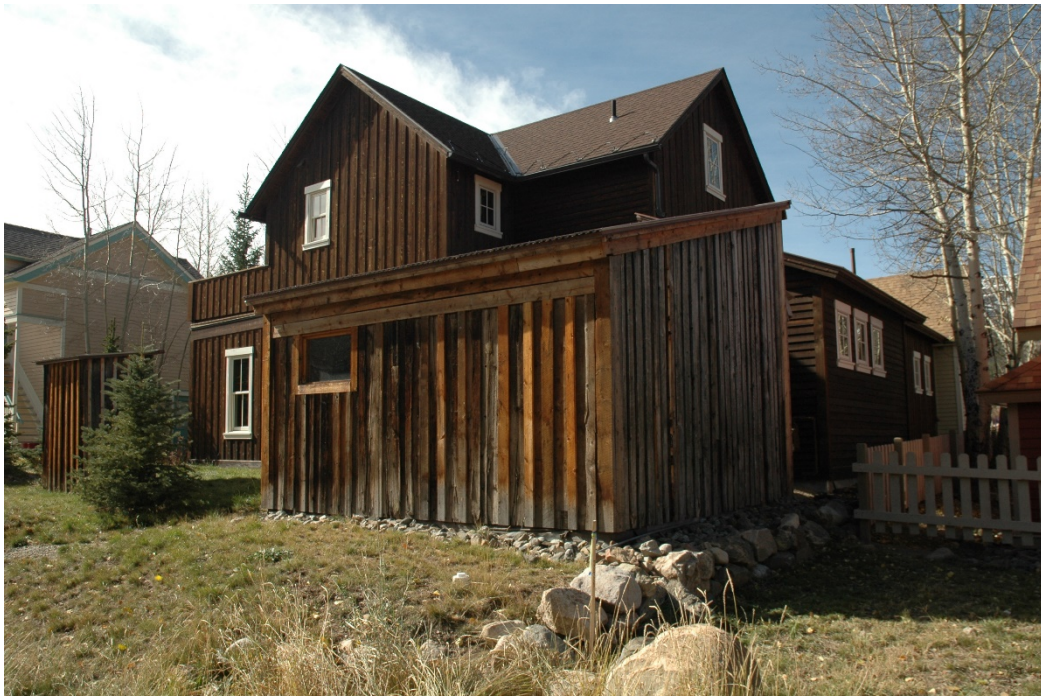
Built in 2014, the two-story rear addition incorporates living space on both levels, and a garage in the ground floor level. It is supported by a poured concrete foundation, and its exterior walls are clad with stained brown vertical wood siding. The roof features intersecting gable and shed roof forms, covered with brown asphalt composition shingles. Windows appear to have white metal or synthetic frames and painted white wood surrounds, with primarily 2/2 double-hung sash and 4-light awning or fixed-pane glazing patterns. A painted white wood-paneled door faces north, but is on the east-facing side of the addition. Two stained brown vertical wood plank rollaway garage doors, with diagonal cross-bracing, are in the west-facing wall. These garage doors open onto a flagstone and concrete driveway that extends along the south side of the historic dwelling to French Street.

CD 1, Image 11, View to Southwest, of the shed and privy, and of portions of the east-facing and north-facing walls of the addition.

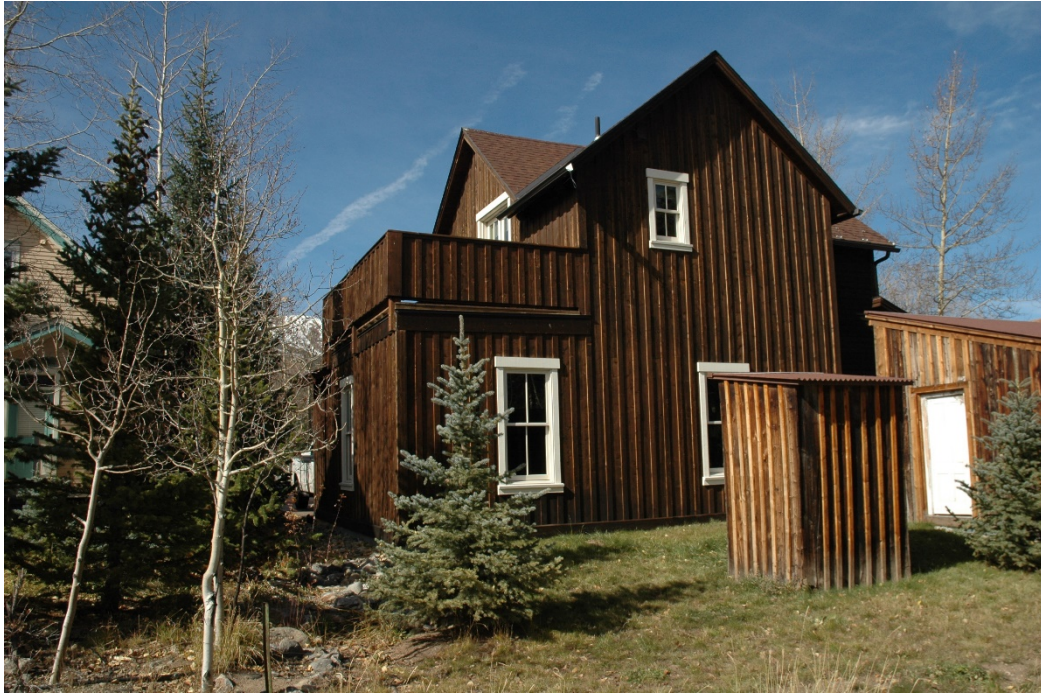
The connecting element has stained brown vertical wood plank walls, and a gabled roof covered with corrugated metal. The south side of the connector contains a glass-in-white metal or synthetic frame door, and a tall 2/2 double-hung sash window, with a white metal or synthetic frame and a painted white wood surround. The north-facing wall of the connector contains a band of three 4-light windows, with painted white metal or synthetic frames and painted white wood surrounds.

CD 1, Image 12, View to Northwest, of the south-facing and east-facing walls of the addition, and of the privy and shed.

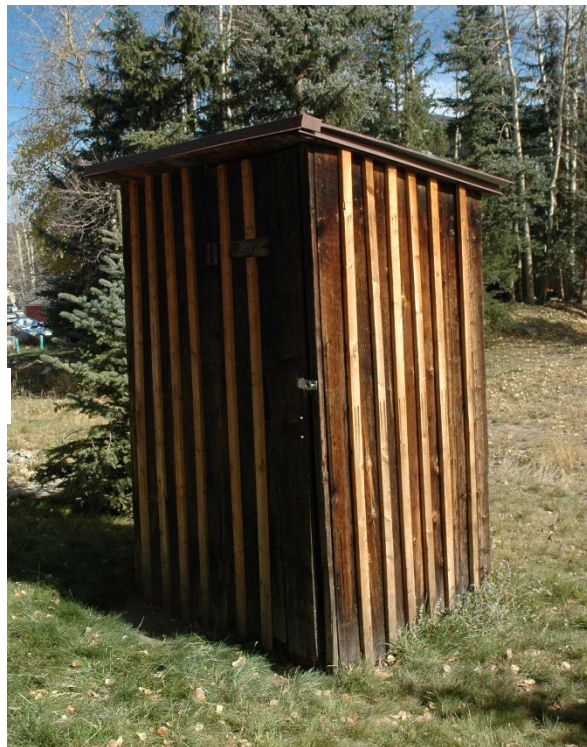
A historic privy, that measures 4½' N-S x 4' E-W, is located near the rear southeast corner of the property. The privy's exterior walls are made of stained brown board-and-batten, and it is covered by a shed roof with corrugated metal roofing material. A board-and-batten door, side-hinged with metal strap hinges, is in the west-facing wall.

CD 1, Image 13, View to Northeast, of the privy.

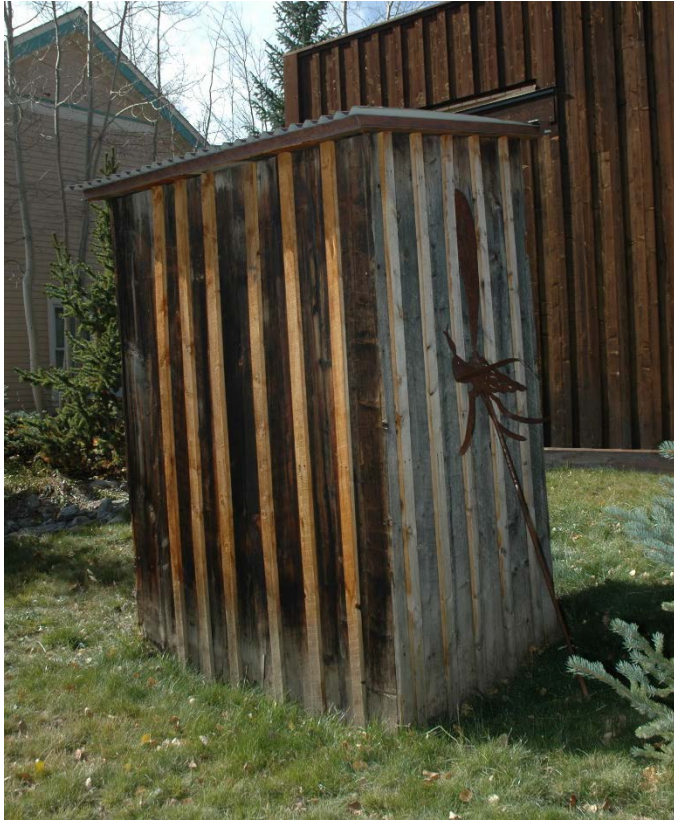
CD 1, Image 14, View to Southwest, of the Privy.

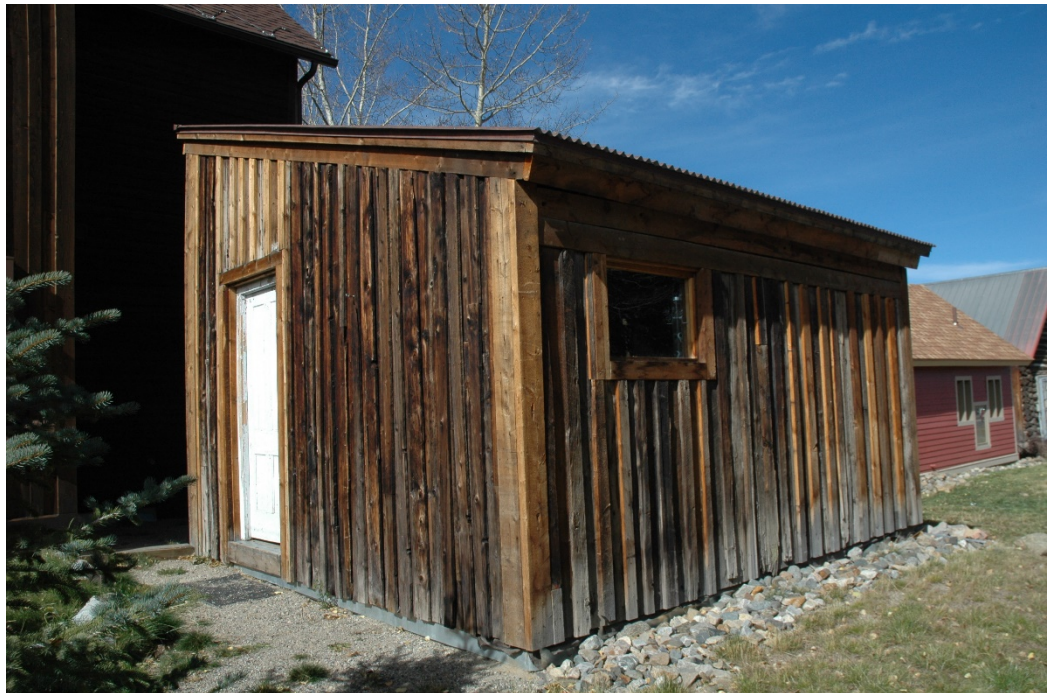
A historic shed, of wood frame construction, is located near the rear northeast corner of the property. Measuring approximately 14' N-S x 12' E-W, the shed rests on a poured concrete foundation. Its exterior walls are made of stained brown board-and-batten, and it is covered by a shed roof with corrugated metal roofing material. A vertical wood plank door is in the west-facing wall, and a painted white wood-paneled door is in the south-facing wall. A single-light fixed-pane window is in the east-

CD 1, Image 15, View to Northwest, of the shed.

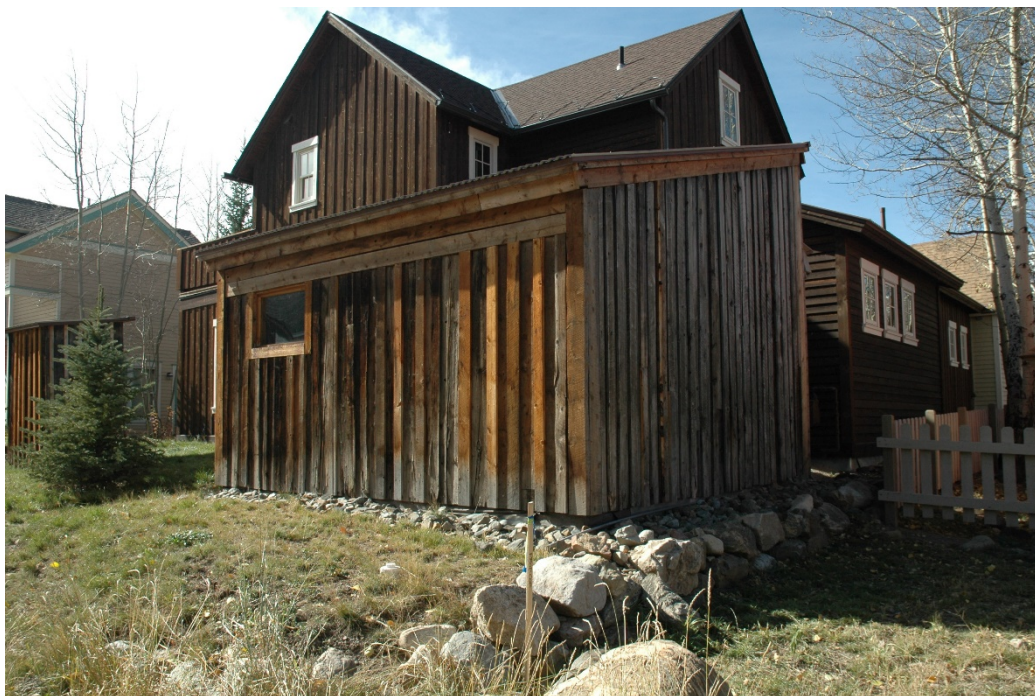
CD 1, Image 16, View to Southwest, of the shed.
