COLORADO CULTURAL RESOURCE SURVEY

Architectural Inventory Form

- 1. Resource number: **5ST130.86**
- 2. Temporary number: **N/A**
- 3. County: **Summit**
- 4. City: **Breckenridge**
- 5. Historic building name: **Bank of Breckenridge Building**
- 6. Current building name: **Bank of Breckenridge Building**
- 7. Building address: **301 S. Main Street**
- 8. Owner name: **Remco LLP**
 Owner address: **471 Kalamath Street**
Denver, CO

48. Report title: **Breckenridge Historic District Historical Building Survey**

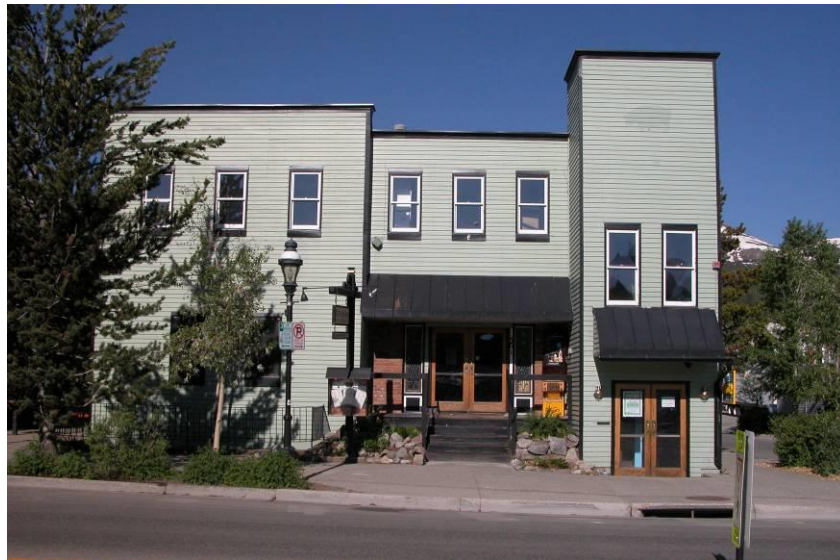
This large commercial building is located at the southwest corner of South Main Street and Adams Avenue. It is of wood frame construction, and features a modified rectangular plan, with overall measurements of 46' across (N-S) by 78' deep (E-W). The building is supported by a painted pale green concrete foundation, while the exterior walls are clad with painted pale green horizontal wood siding, with painted red 1" by 4" corner boards. The roof is flat, with parapet walls extending above the roof line on all four sides. Windows on the facade (fronting toward Main Street on the east elevation) include: eight 1/1 double-hung sash windows in the second story; two 1/1 double-hung sash windows in the first story; and three 1x1 horizontal sliding garden level windows, which are partially hidden behind a black wrought iron railing at the south end of the facade. North elevation windows include: a set of seven 2-light awning first-story windows, topped by a band of nine large vertically-oriented single-light fixed-pane windows; a band of nine 2-light awning second-story windows; and six single 1/1 double-hung sash windows. Windows on the west (rear) elevation include: four first-story 1/1 double-hung sash windows, and eight second-story 1/1 double-hung sash windows. The windows throughout all feature painted wood frames and surrounds. A set of paired, stained natural brown, glass-in-wood-frame doors, flanked by leaded glass sidelights, lead into the building from a recessed 5-step wood porch near the center of the facade. This doorway is the main entrance into "Kenosha Steakhouse." Another set of paired, stained natural brown, glass-in-wood-frame doors enter the building at the north end of the facade. This doorway is the main entrance into "Rita's Specialty Marg's. & Taco Bar." On the west elevation, one other set of paired, stained natural brown, glass-in-wood-frame doors open onto a rear porch, covered by a gabled roof. A large outdoor dining area is also located adjacent to the west elevation. A 10' by 18' shed-roofed wood frame building, located just to the southwest of the main building, encloses a walk-in refrigerator.
